NASA Contractor Report 4664

# Analysis of Materials Flown on the Long Duration Exposure Facility: Summary of Results of the Materials Special Investigation Group

*H. Gary Pippin*

*H. Gary Pippin*  
*Boeing Defense & Space Group • Seattle, Washington*

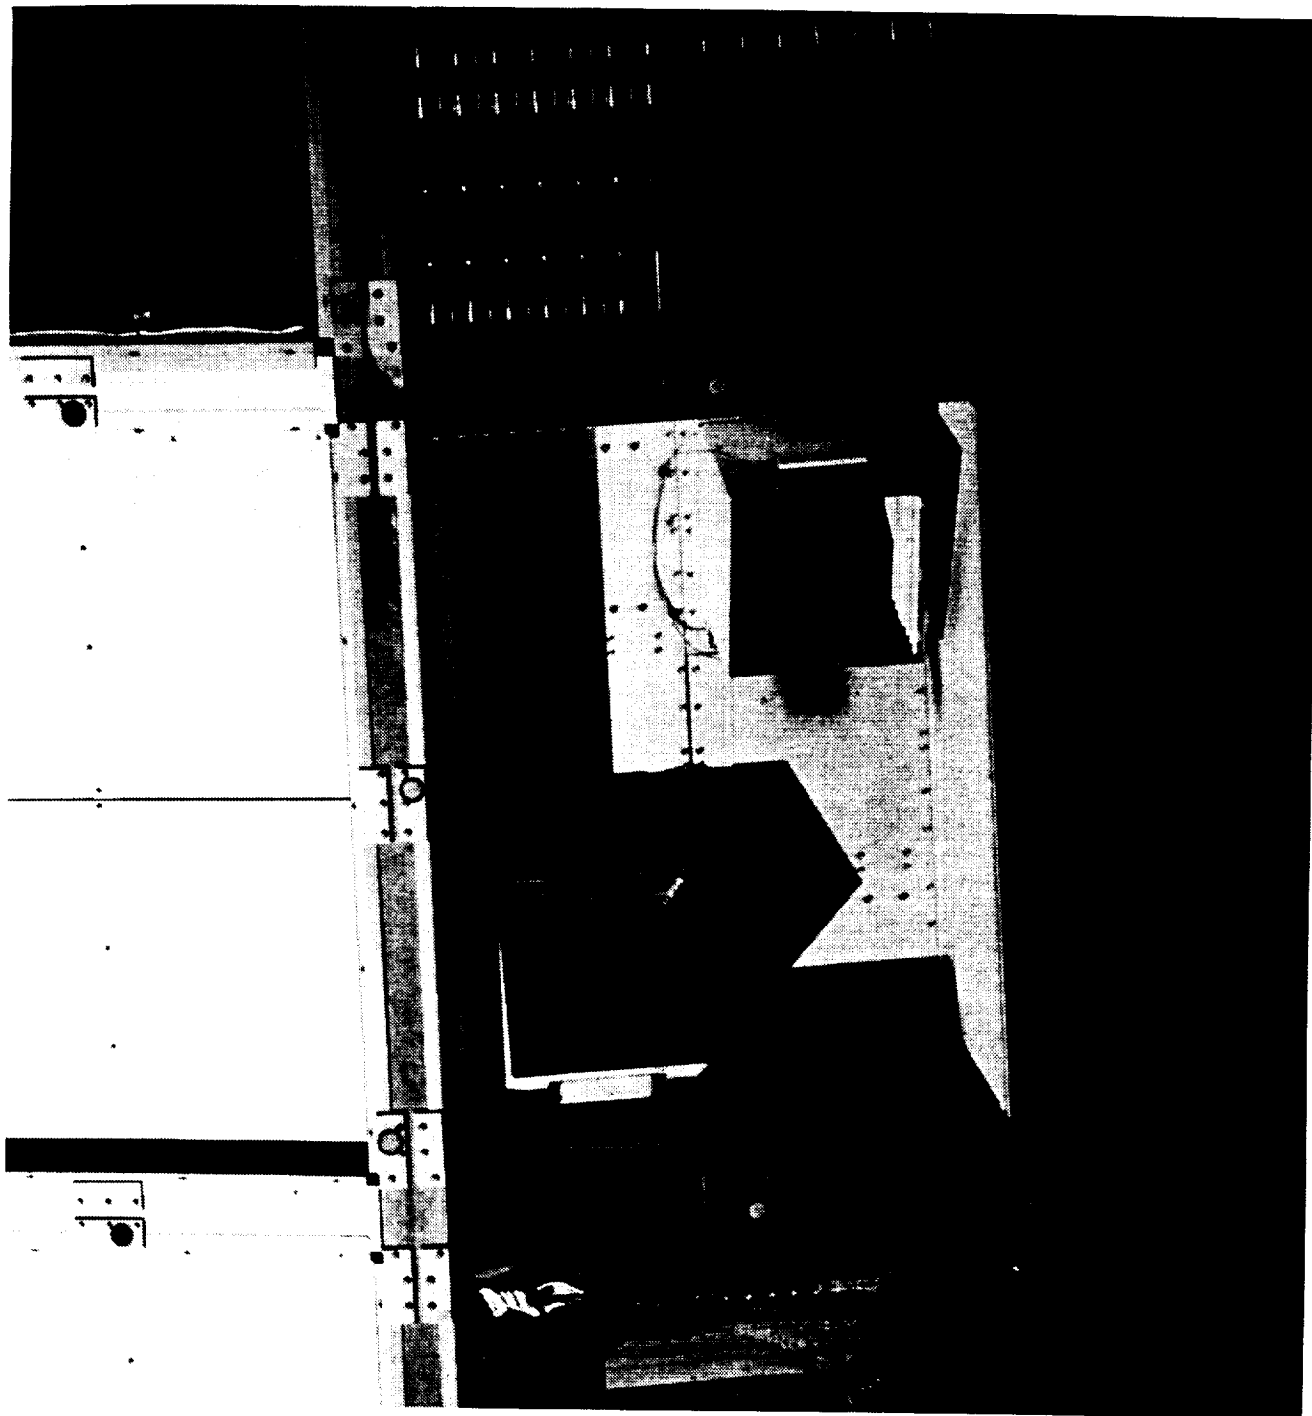
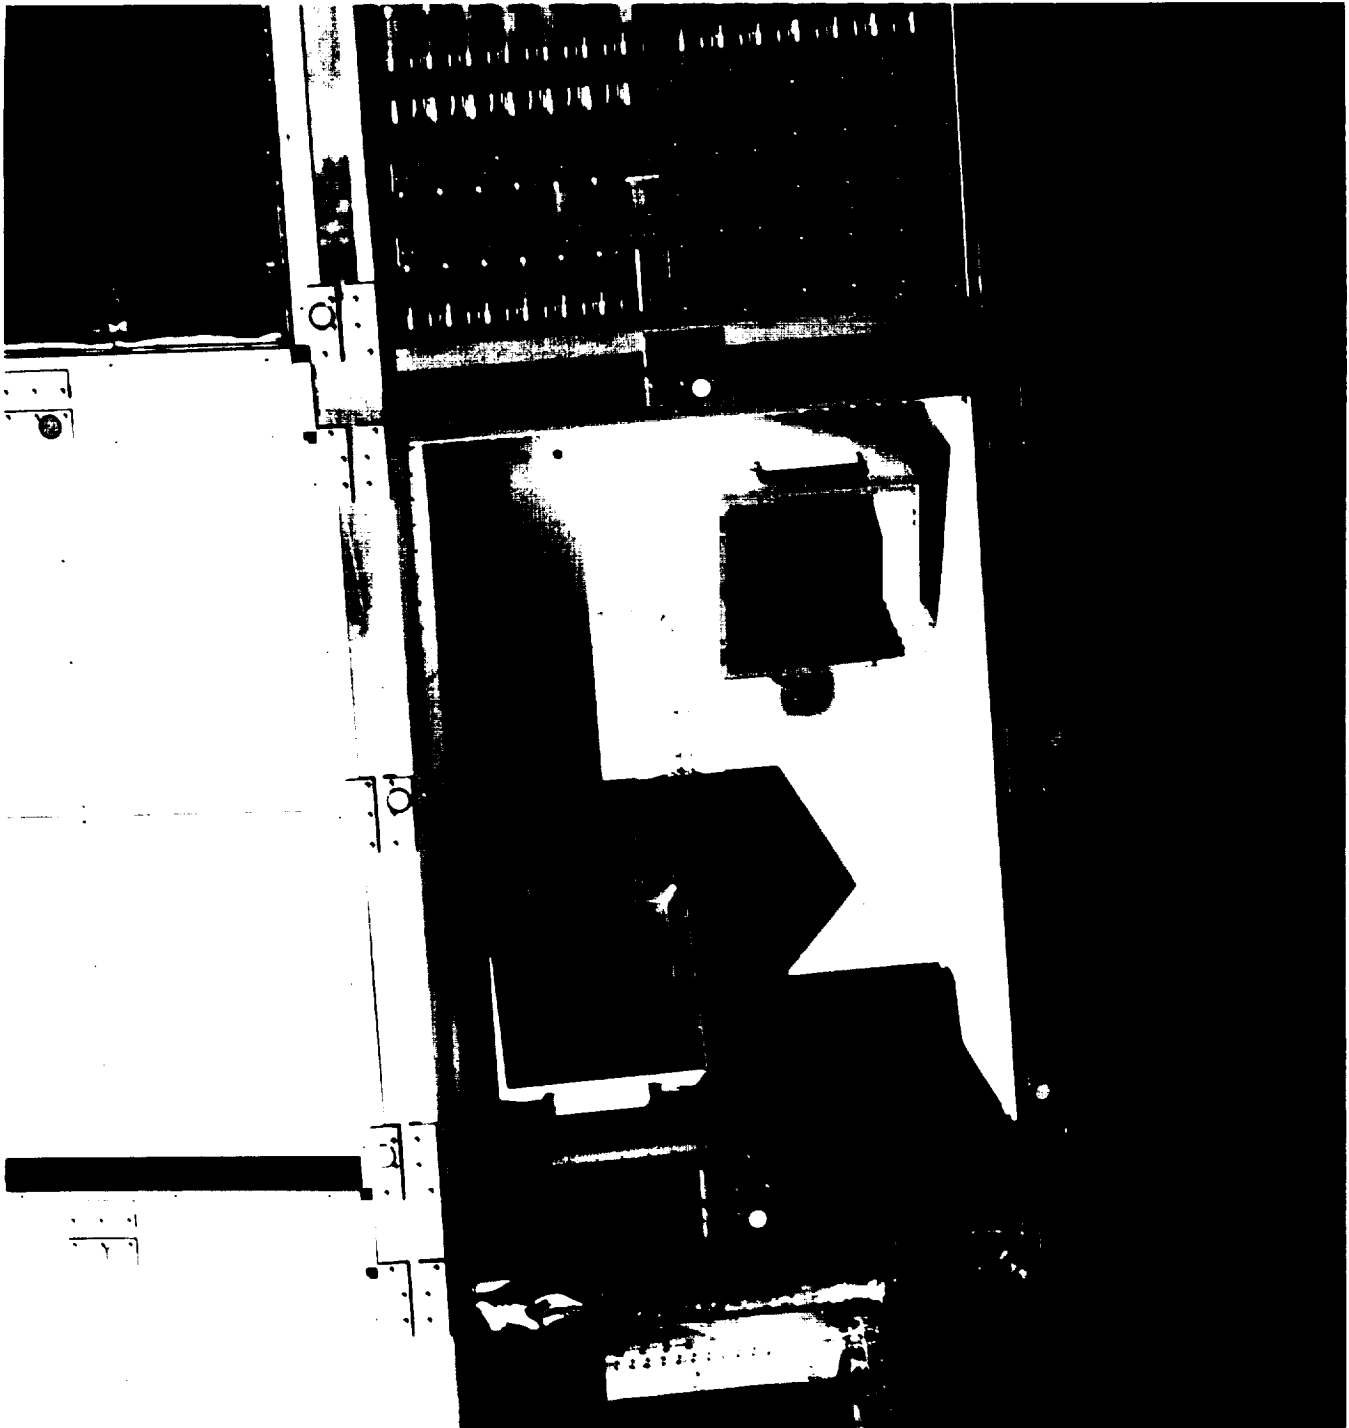
The trays for experiment AO038 (E12, H12, H6) were designed to be the coldest location on LDEF. Figure 7.1-9 is an on-orbit photo of tray E12 showing the contamination around the electrical connectors. The lower right corner of the tray also shows discoloration. Cold surfaces facilitate the deposition of volatile species. The contaminated areas are very distinct and localized on these trays, suggesting very specific sources.

Figure 7.1-9. NASA on-orbit photo of tray E12, showing experiment A0038.

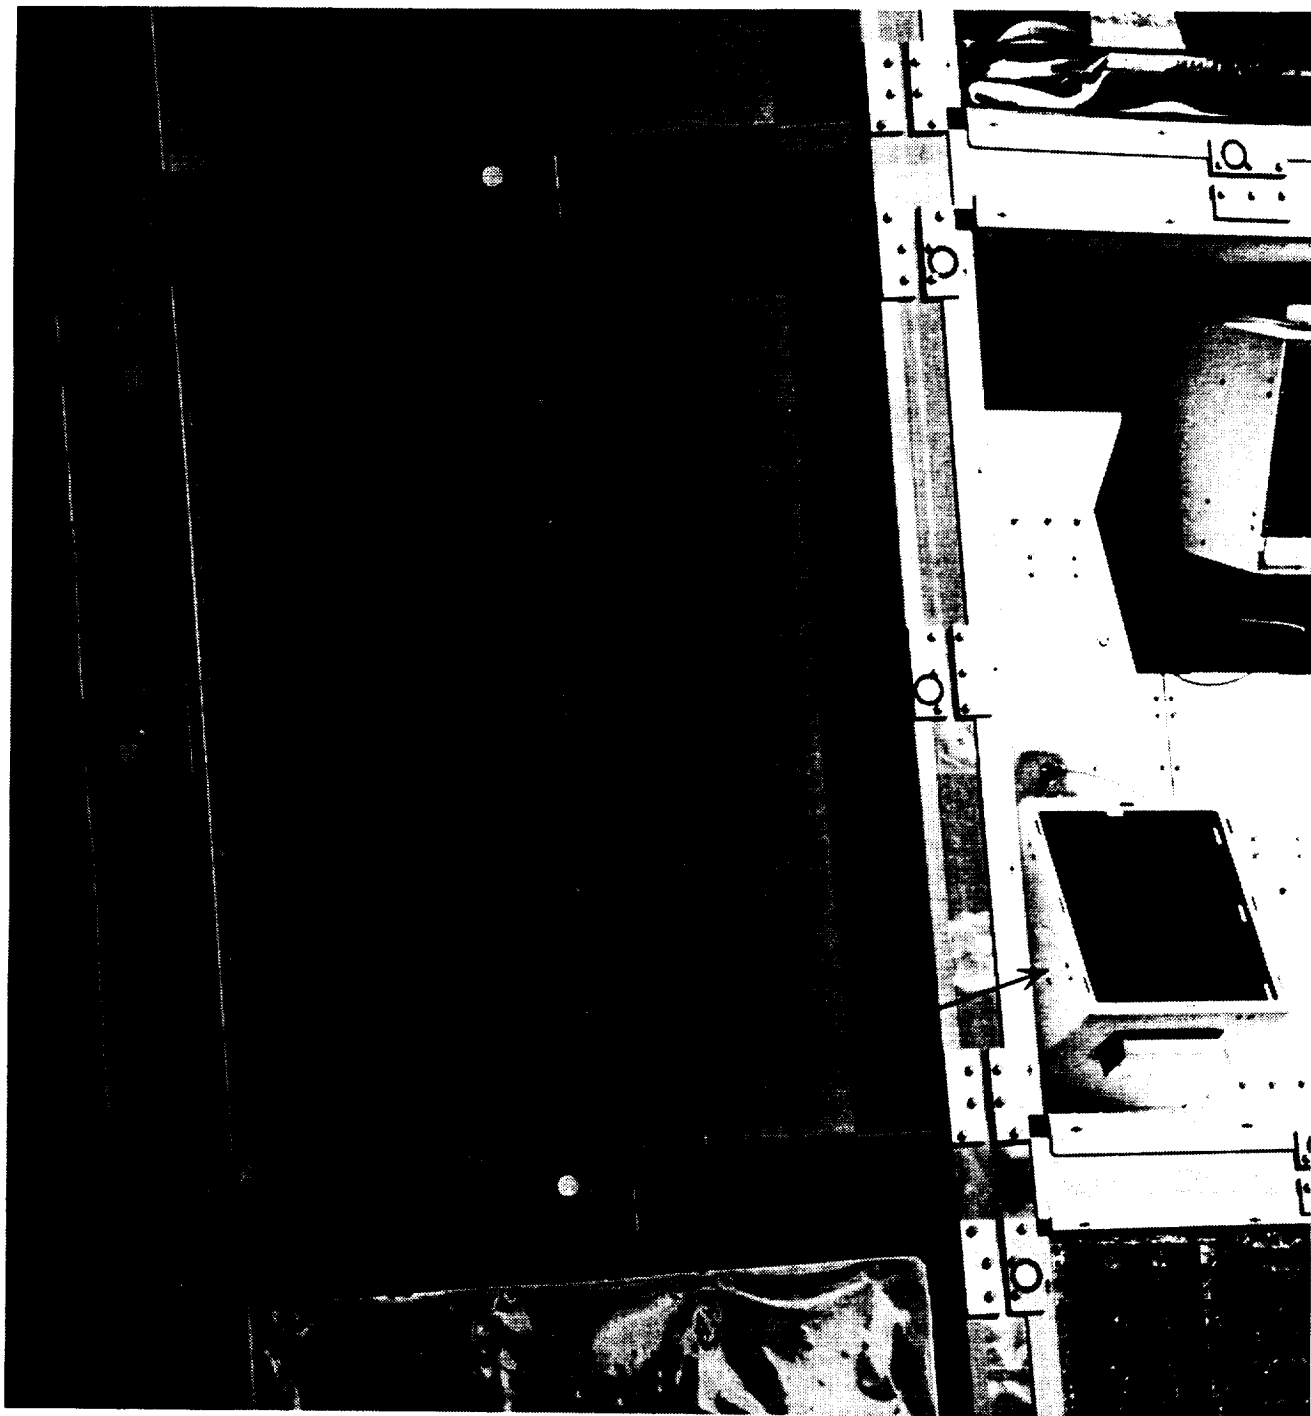
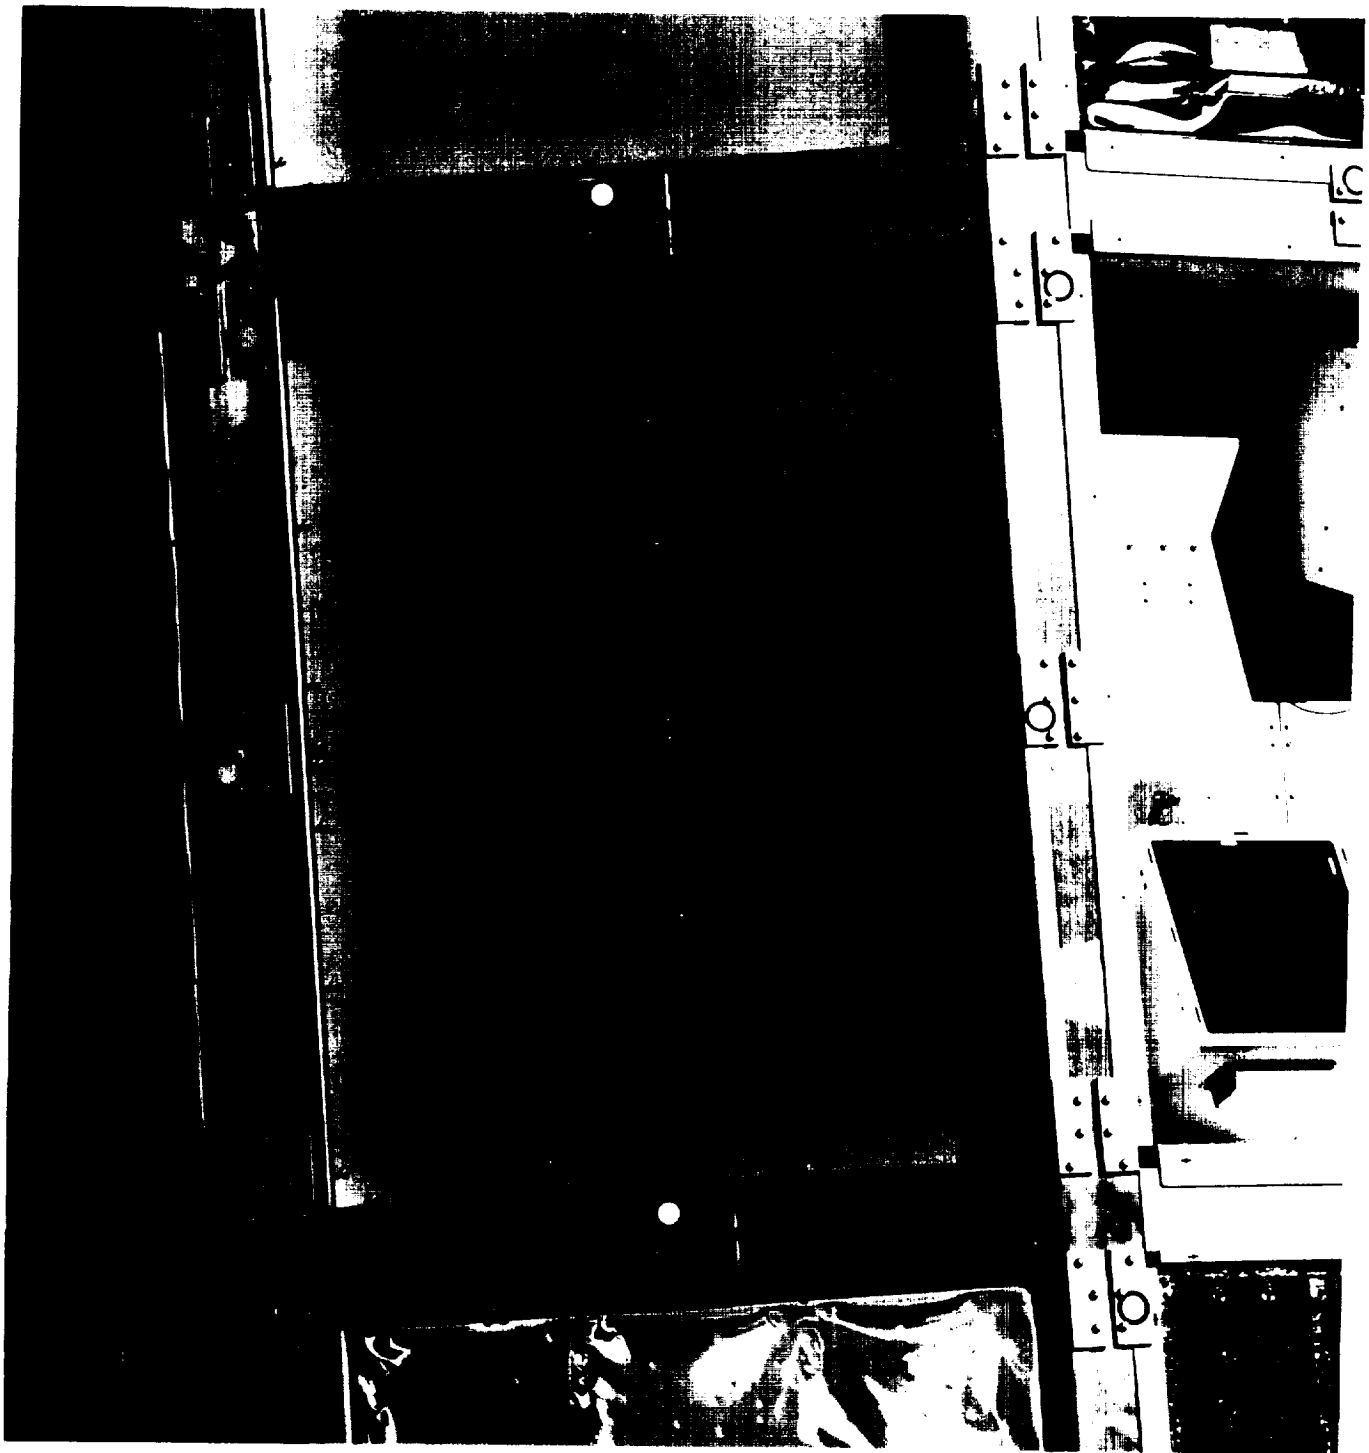
Figure 7.1-10 is an on-orbit photo showing an anodized aluminum thermal balance panel, E11, and a portion of tray E12 on the right. The IGE "camera" openings (tray E12) have wire grids toward their tops. This grid had collected a number of gold-colored flecks of material, most likely debris from the failed aluminized mylar and/or Kapton blankets on the leading edge. Most of this material was removed during reentry.

Figure 7.1-10 NASA on-orbit photo showing debris particles on the wire grid of the interstellar gas experiment cameras. (Color figure C-10)

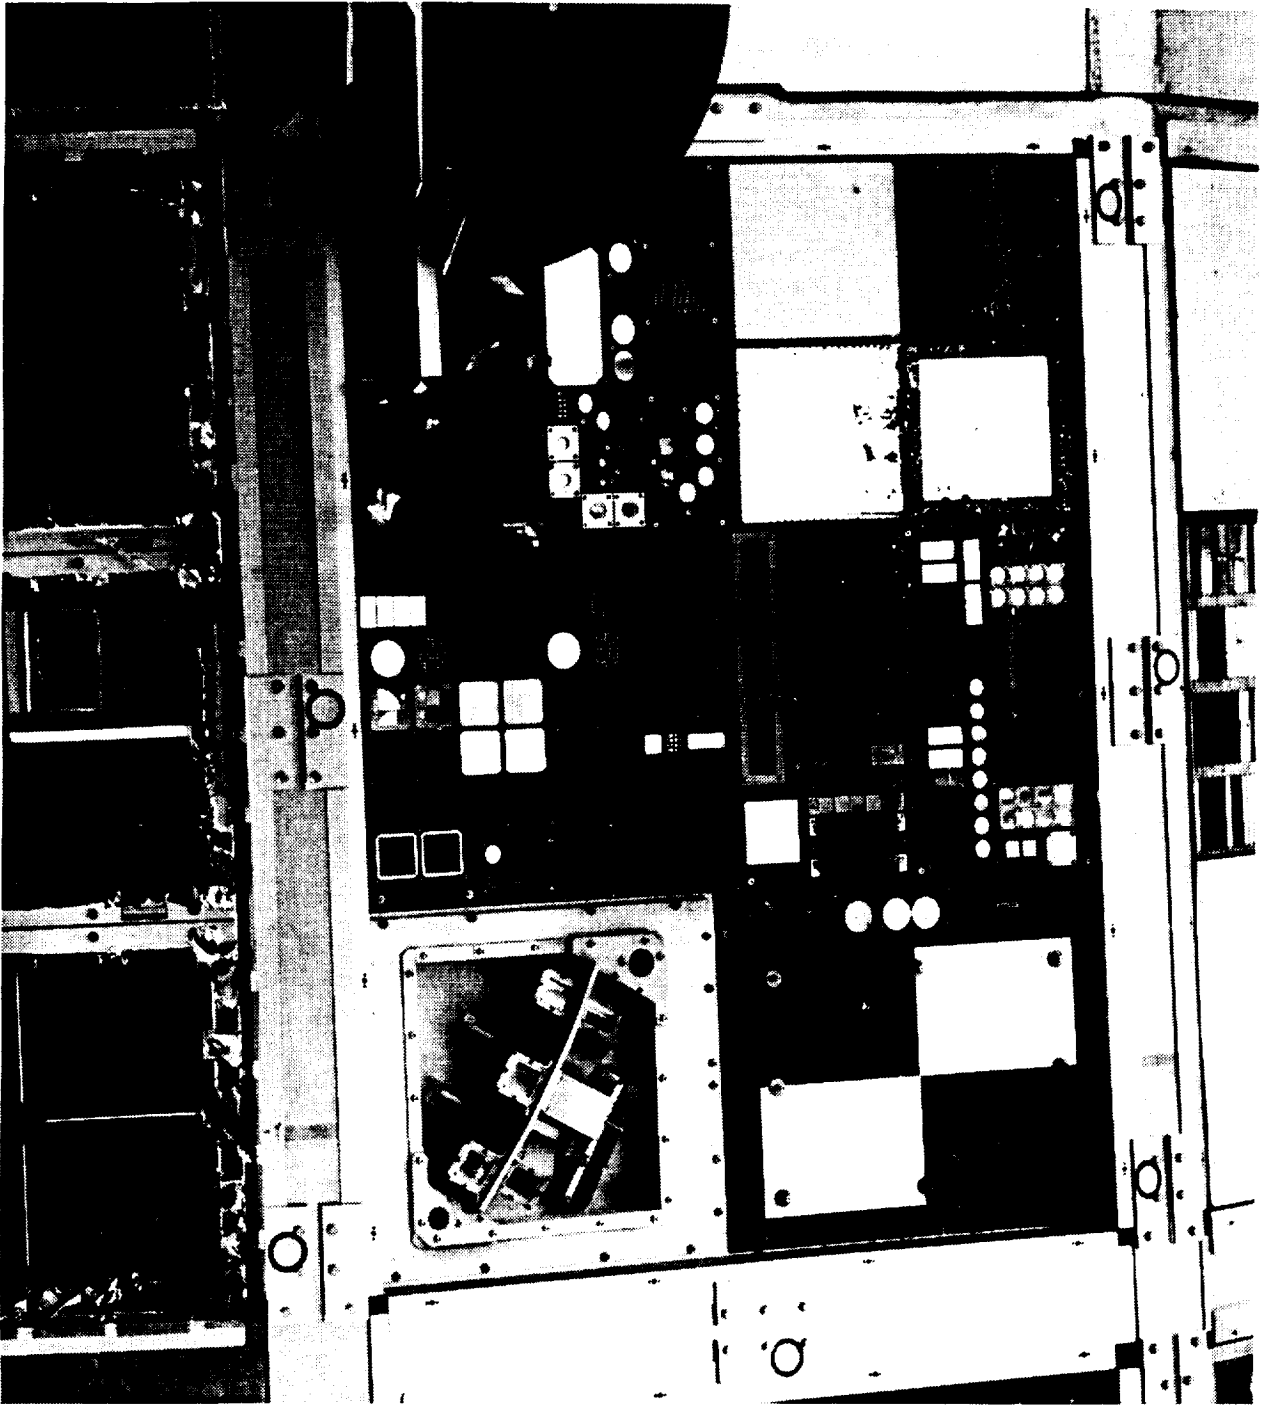
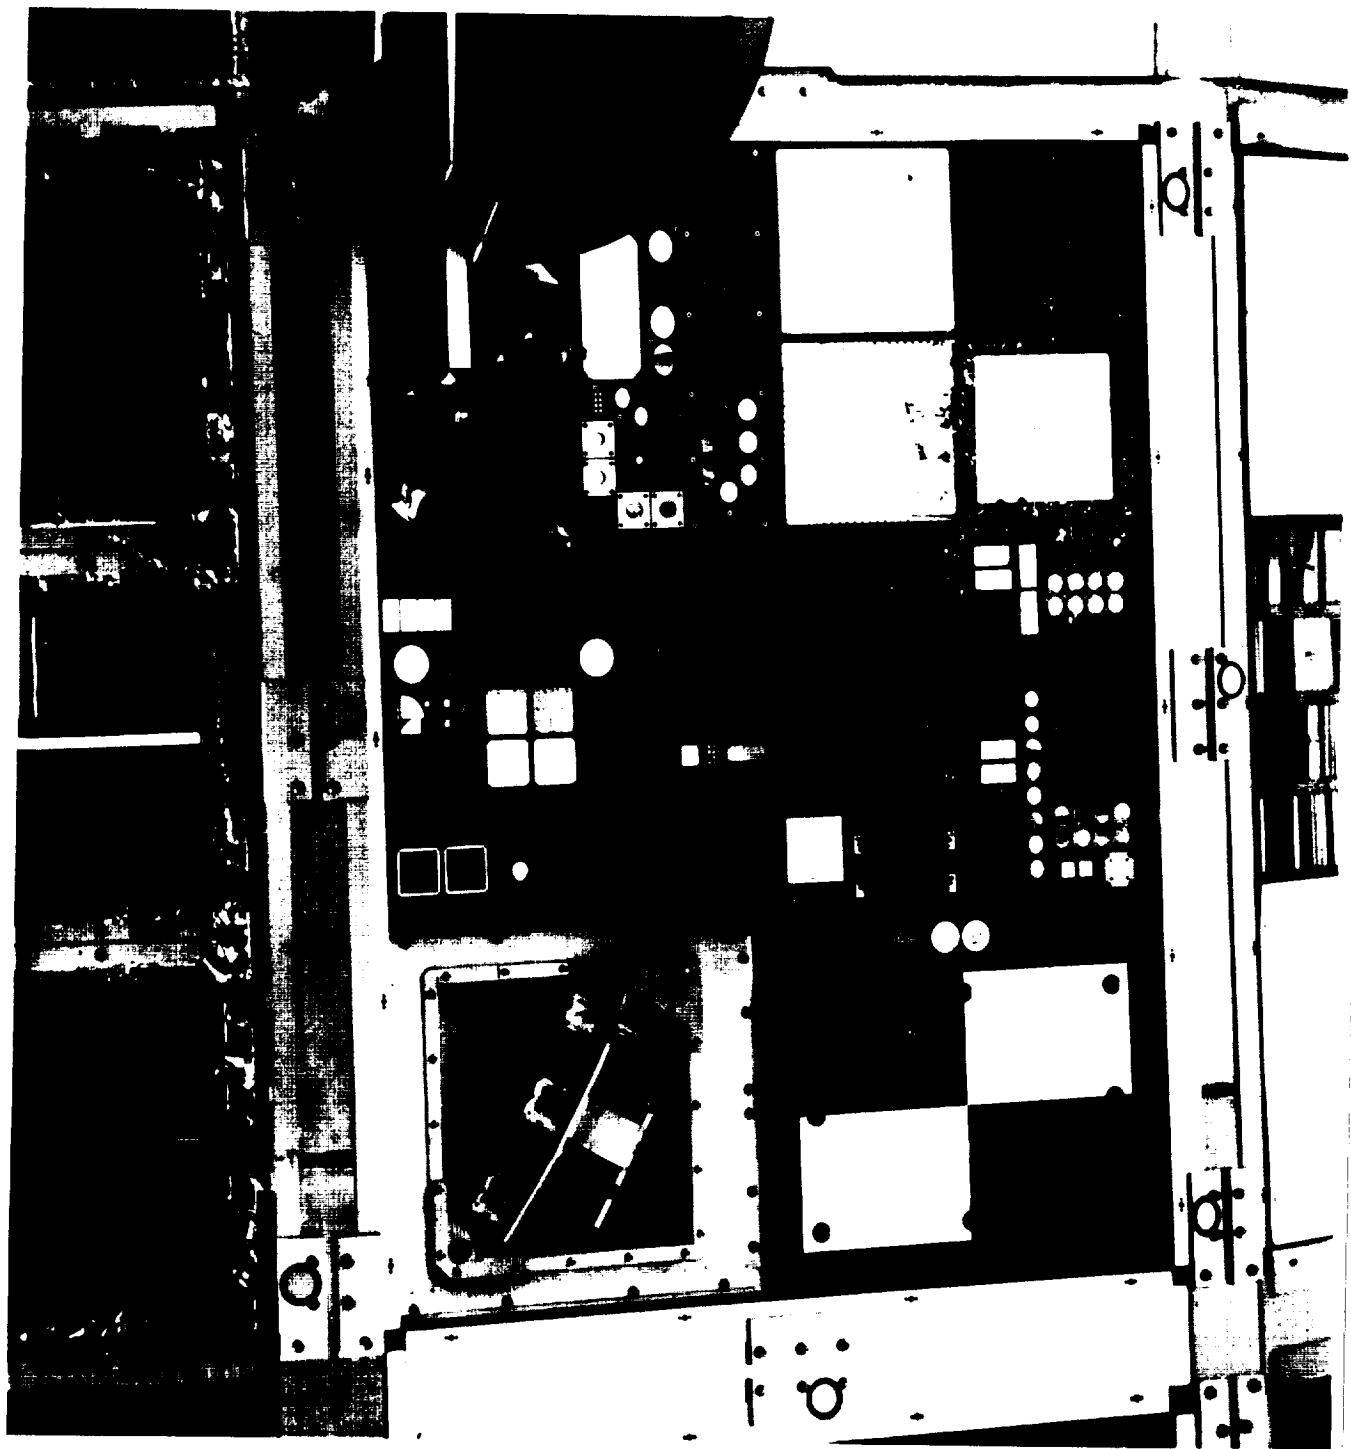
Failed blanket materials from trays D9 and D10 distributed small particles of aluminum over many nearby surfaces. It is hard to quantify the effects for these occurrences because the time of failure is not known, and the particle distribution probably changed with time.

Figure 7.1-11 is a NASA on-orbit photo showing tray D9. Particulate debris from failed blankets on M0002 is distributed across tray D9. This debris was also essentially removed during reentry. The time of failure, when the particulates were distributed over tray D9, which may have been an extended time period, is unknown.

Figure 7.1-11. NASA on-orbit photo showing debris on tray D9. (Color figure C-11)

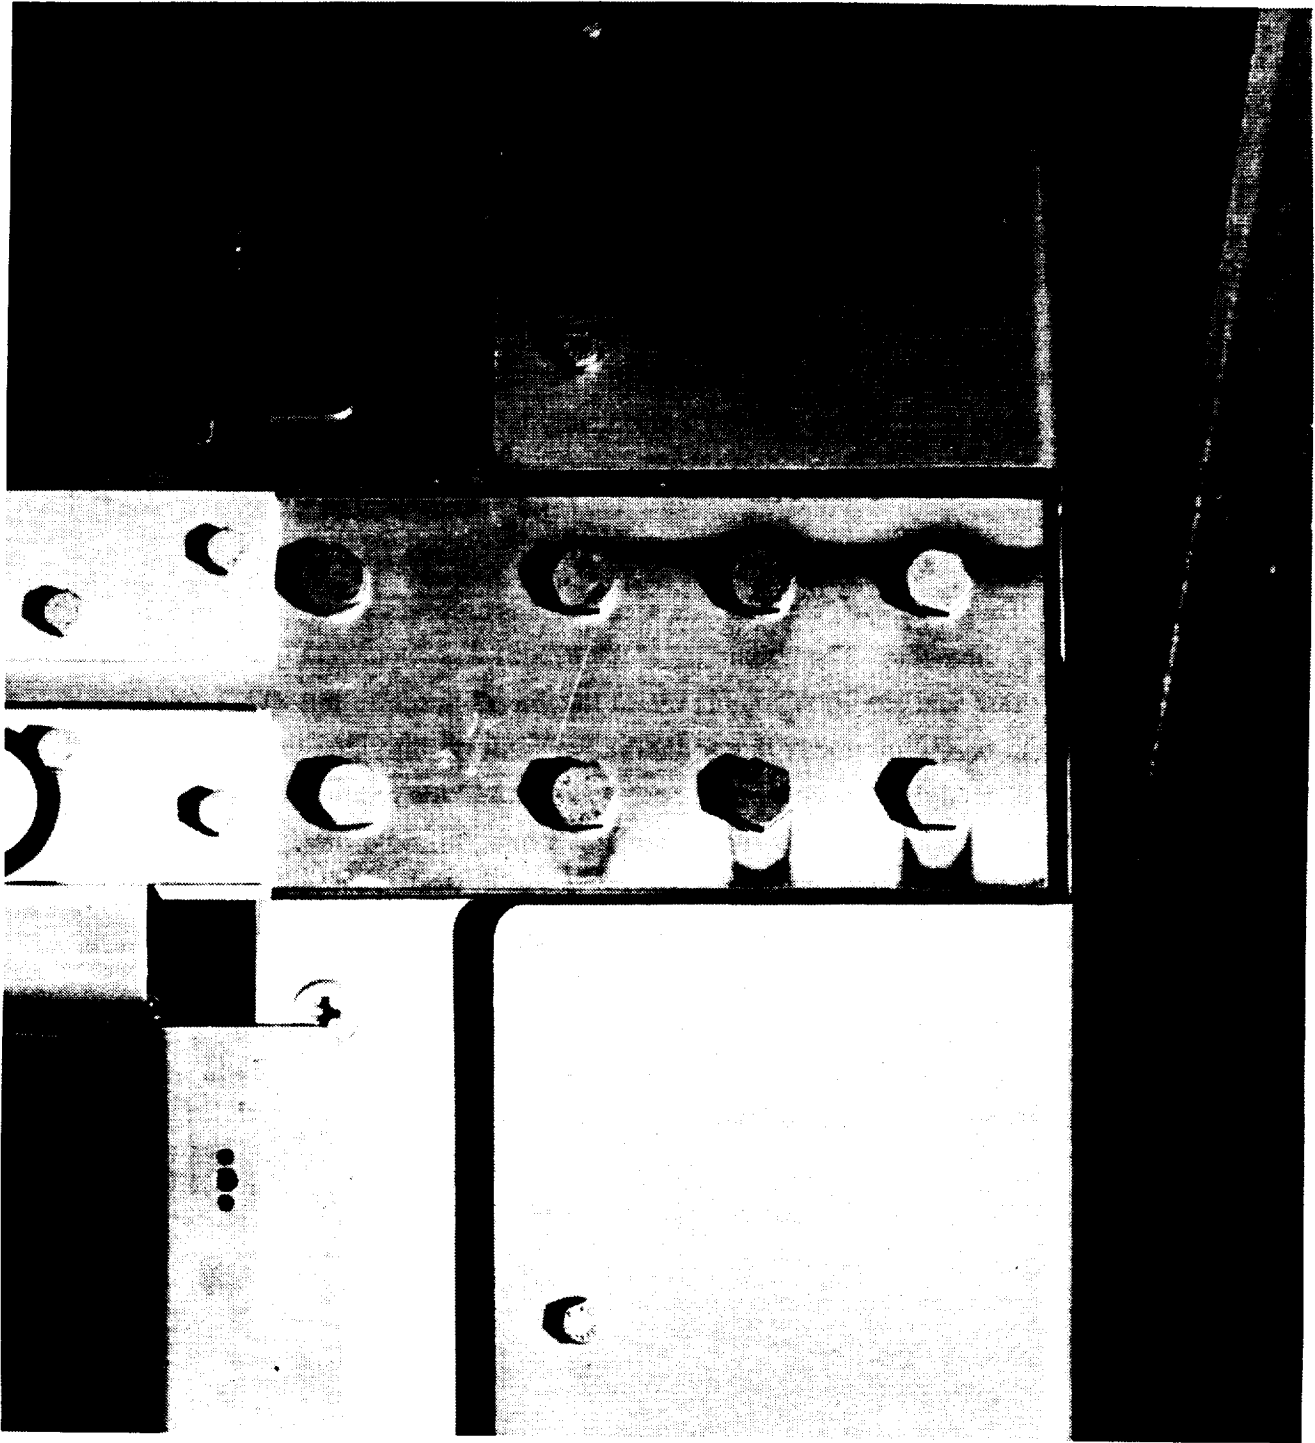
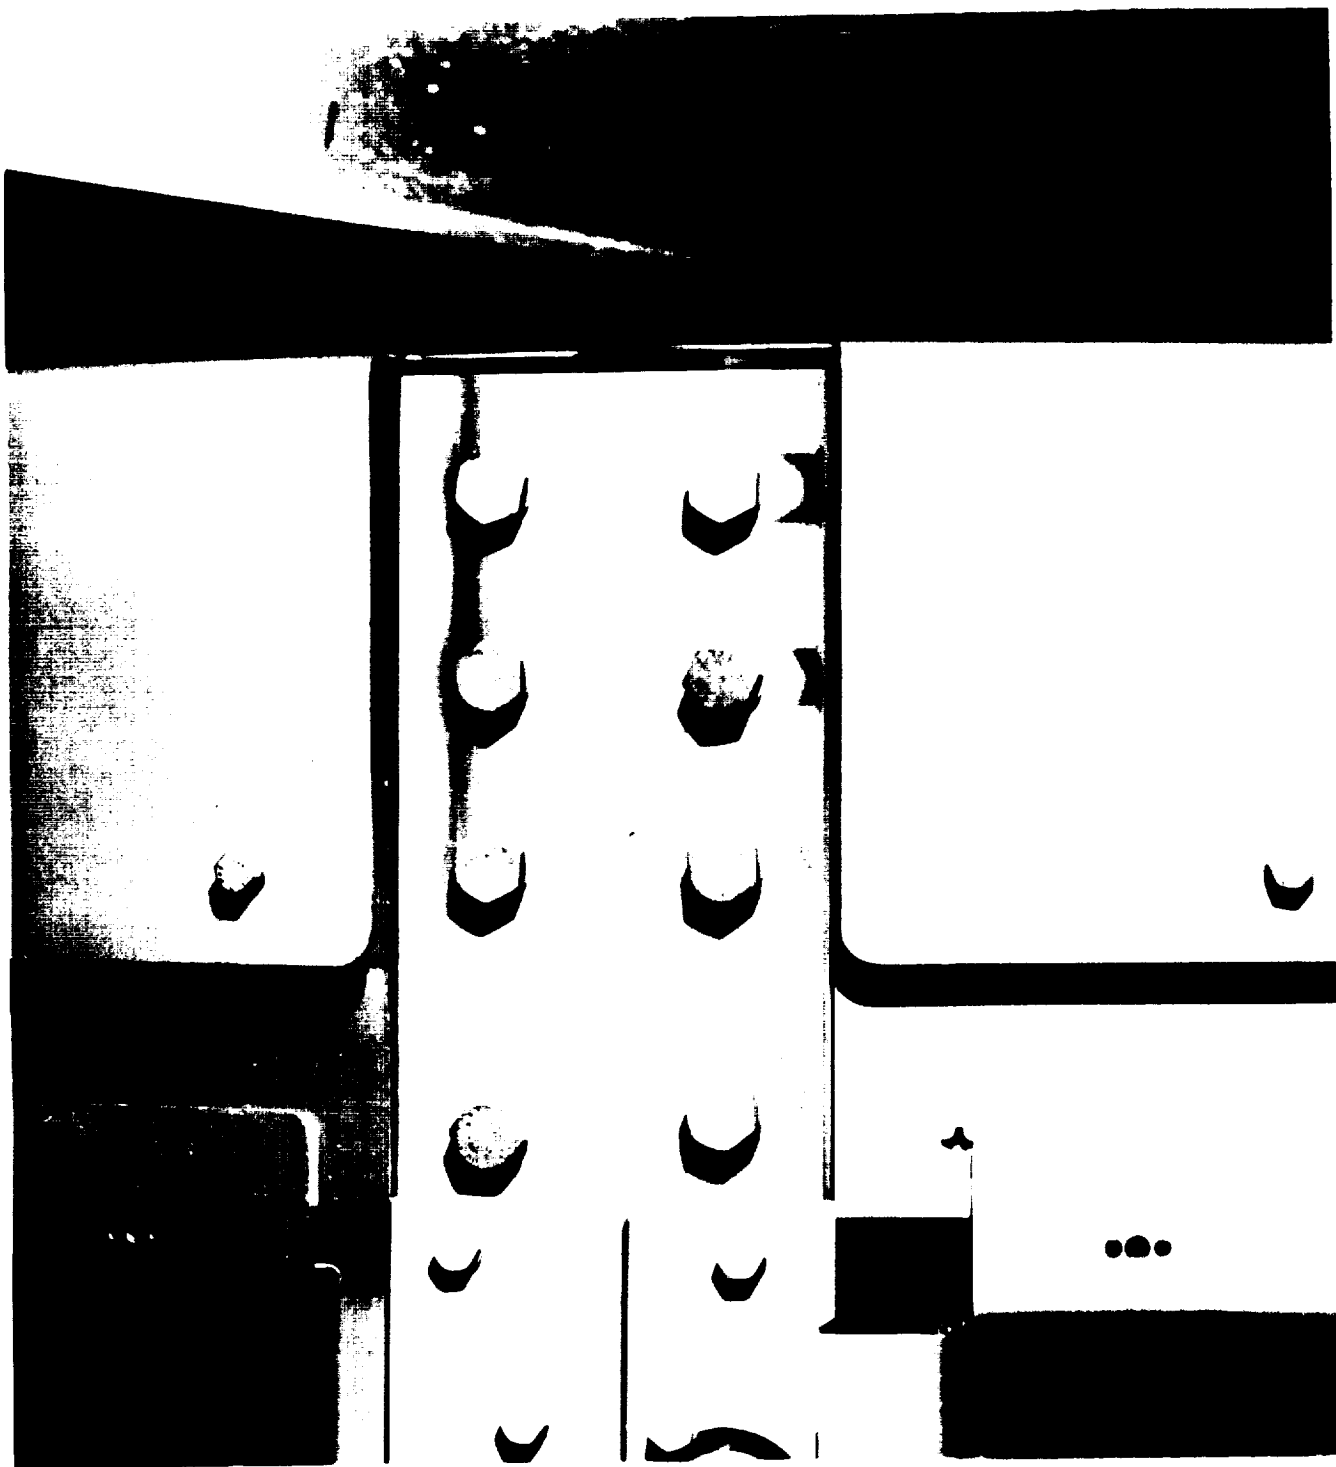
In figure 7.2-2, atomic oxygen exposure was from the left at 67° from normal to the longeron surface. This exposure "cleaned" the area of the longeron surface between the lower set of bolts in the photo. The remainder of the pattern was dependent upon which areas immediately saw sunlight upon coming out of the Earth's shadow, and which areas were in shadow and heated indirectly due to thermal conduction through the aluminum prior to receiving direct solar radiation. "Sunrise" was "above" the photo. Areas where material had deposited and were exposed to sunlight while still cold have significant discoloration where material was photopolymerized. Areas in shadow at "sunrise," such as just below the lower set of bolts, or at the extreme top of the longeron, which was shielded by the raised panel, were warmed indirectly. This allow materials at these locations to volatilize before the Sun moved into a position to radiate directly onto these areas. The net result was that areas still in shadow at "sunrise" did not have any contaminant material left to react and darken.

Figure 7.2-2. NASA post-flight photo of contamination deposits on longeron between trays F11 and F12. (Color figure C-13 rotated 90°)

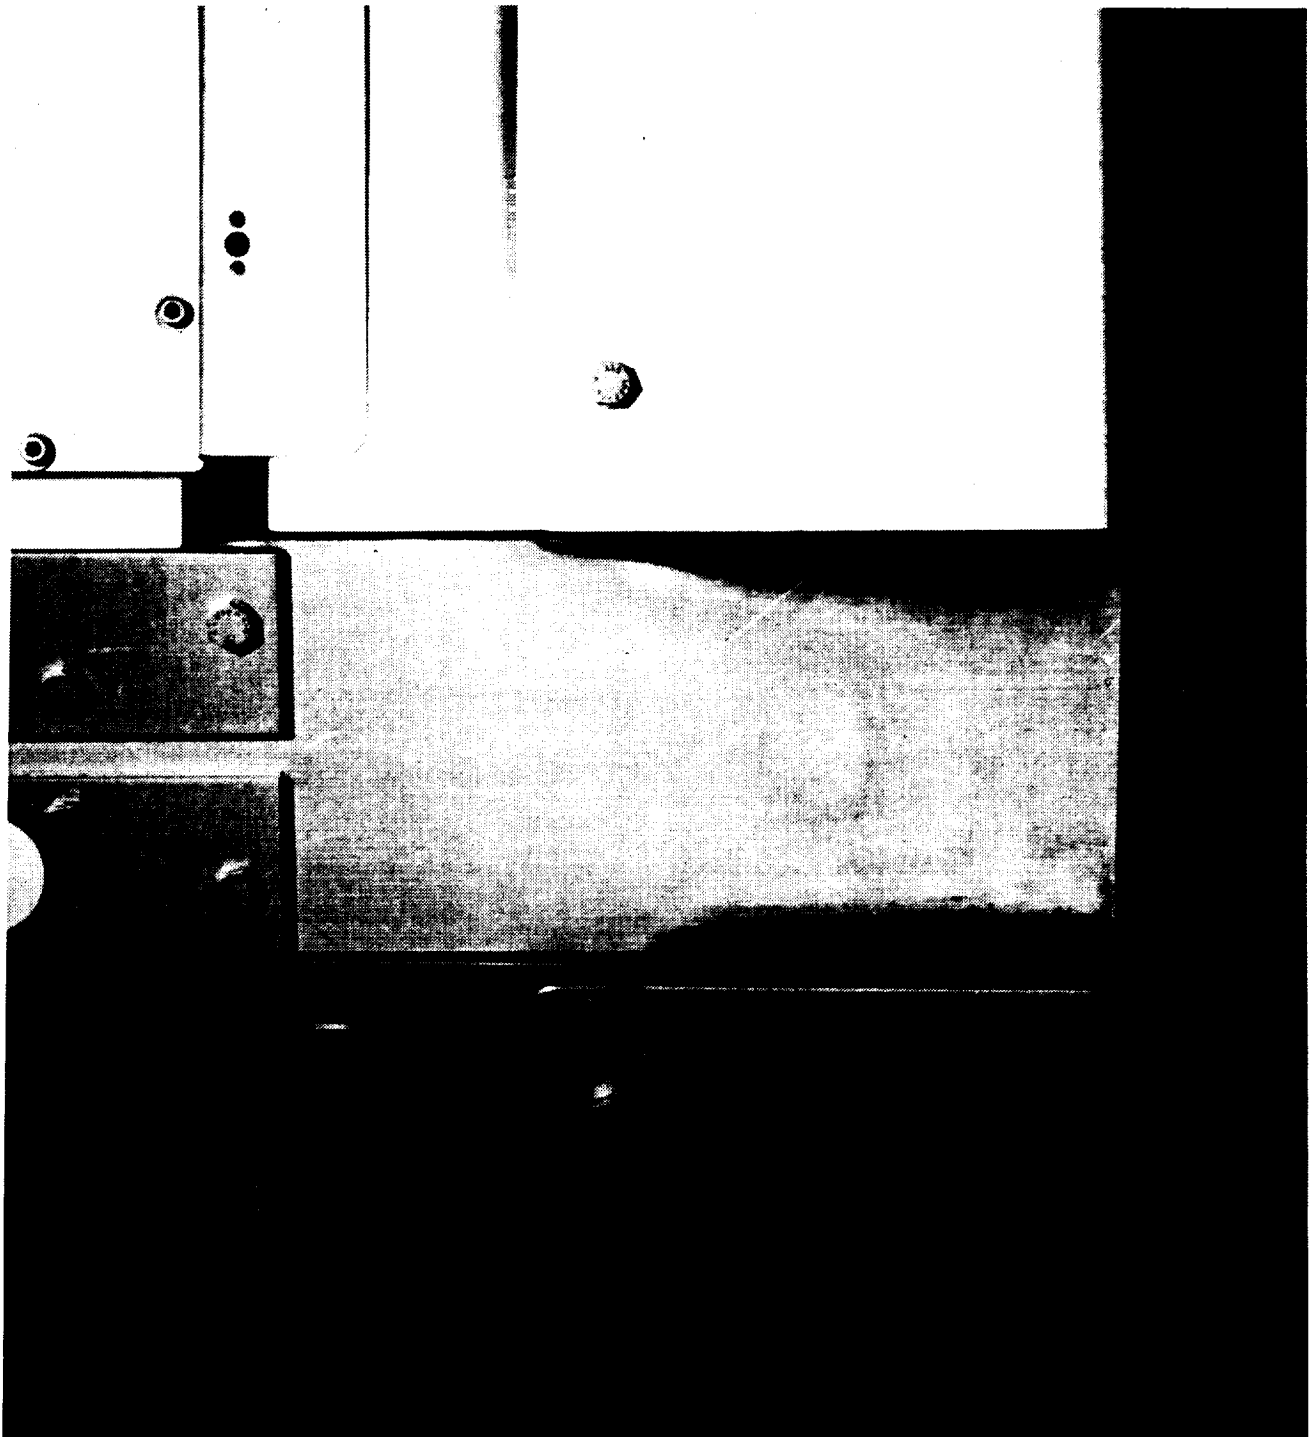
The amount of material vented at this location appears greater than for the location in figure 7.2-2. Darkened areas are seen along the rows 10 and 11 facing surfaces, as well as both sides of the longeron. The heavier deposit seen at the top half of the longeron in the photo are in an area shielded from atomic oxygen. The darkened area at the bottom half of the longeron has likely been eroded by atomic oxygen. This material has not been analyzed, but it likely contains significant amounts of silicates which have both trapped and protected other species from atomic oxygen.

Figure 7.2-3. NASA post-flight photo of contamination deposits on longeron between trays F10 and F11. (Color figure C-14)

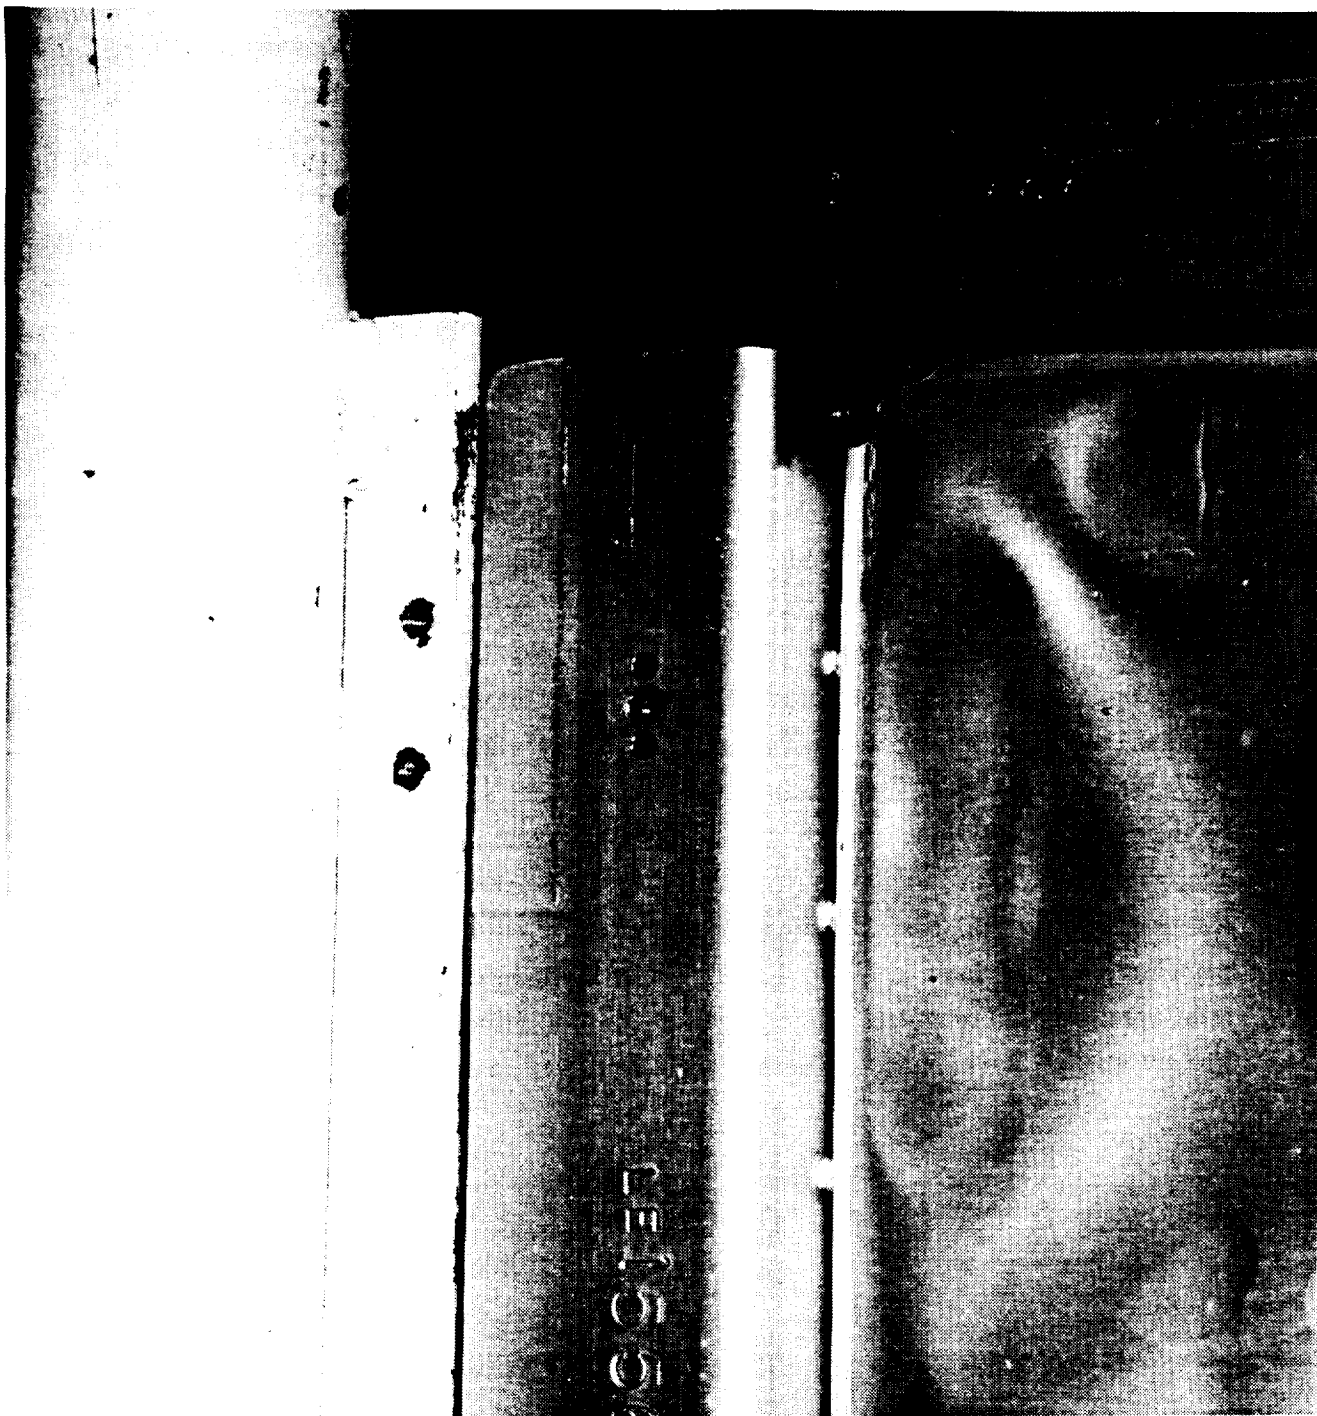
As a comparison with the contamination on the external tray sides, figure 7.2-15 shows a NASA photo of the interior of a corner of tray D11. This photo shows the pattern from venting of an AO178 tray. The discoloration is extremely localized in this case and is essentially line of sight from the opening at the blanket corner.

Figure 7.2-15. NASA post-flight photo of outgassing deposits at interior of corner of tray D11. (Color figure C-26)

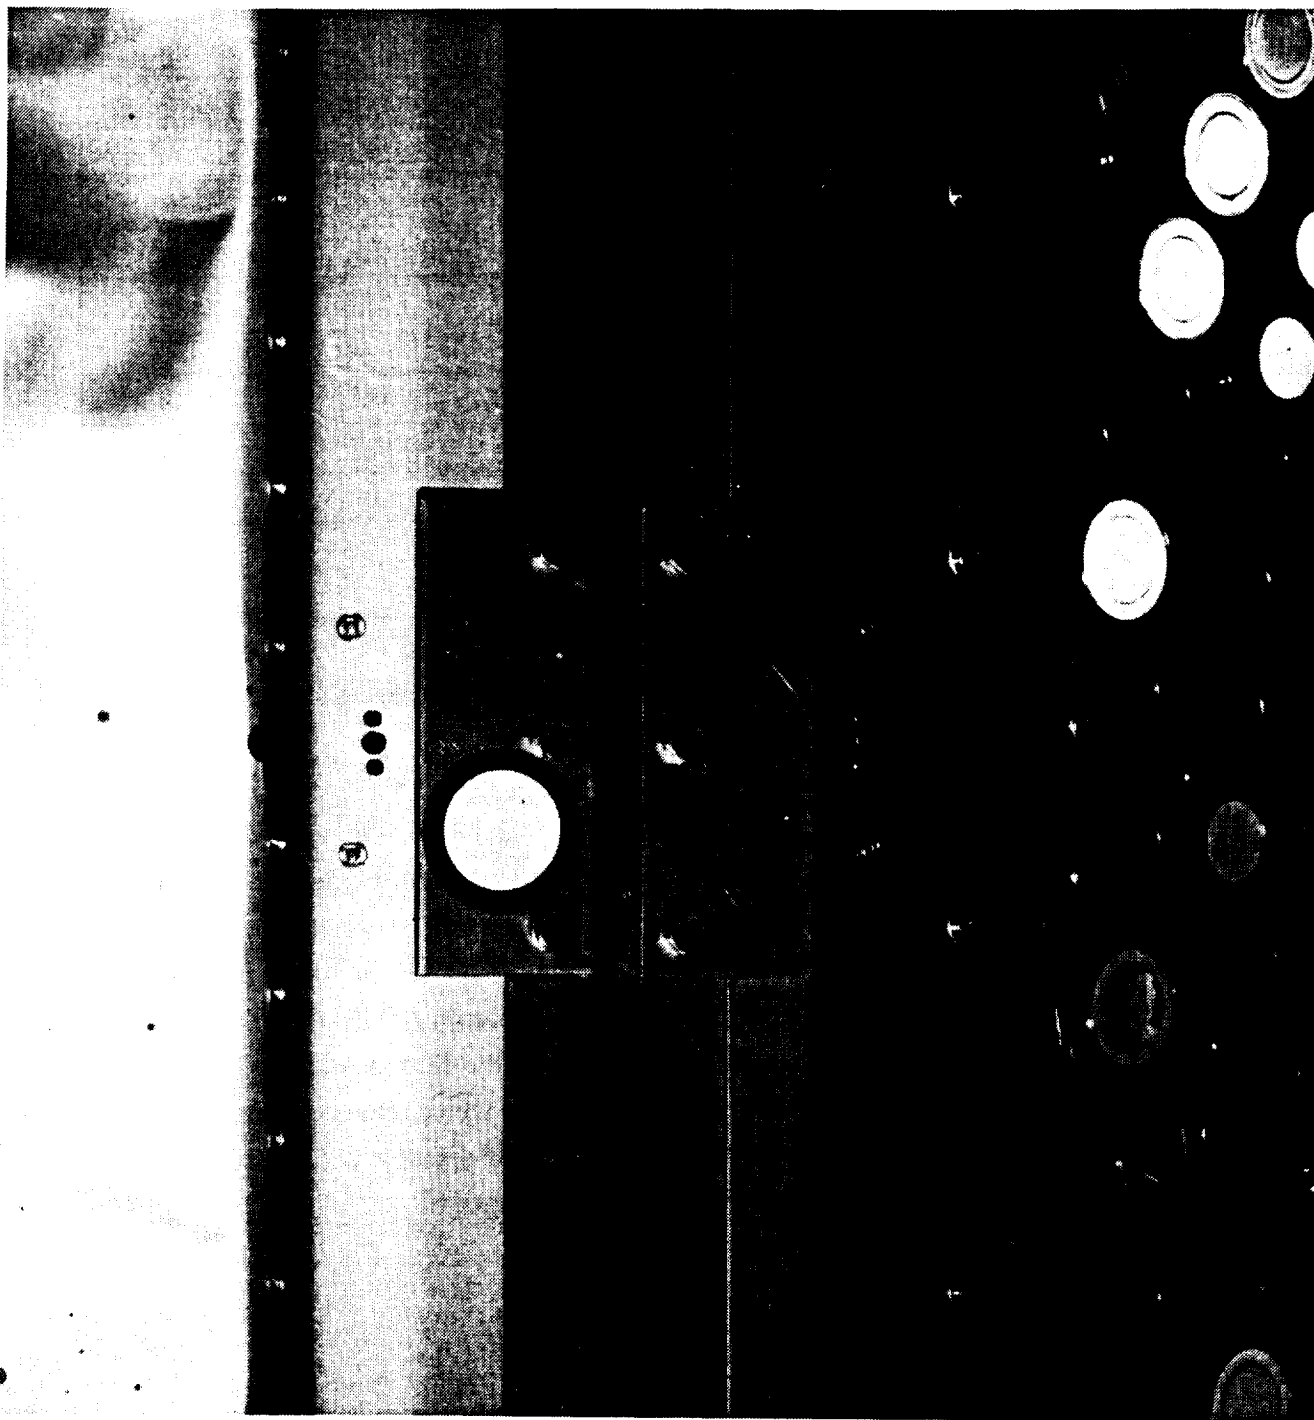
Figure 7.2-19 is a photo showing results of the 69 months exposure on several of the S0069 specimens and nearby hardware. Silicone coated paint specimens, which failed severely on-orbit, are visible on the lower righthand side of the photo. A leading edge paint button with a partially eroded Z306 ring is visible. Comparison with the exposed Z306 ring around the A276 paint buttons shown in figures 7.2-16 and 7.2-17 shows slightly more of the Z306 remains on the anodized tray clamp. A small portion of the silverized Teflon blanket A10, showing a number of impact sites and the associated delaminated areas, can be seen on the left. The area on the A10 tray adjacent to the vent slot in the Ag/FEP blanket shows evidence of deposition of material vented from the inside of the tray.

The failed silicone specimens from S0069 show that components, such as solar cell arrays, protected by thin silicone coatings, may be susceptible to performance degradation due to darkening, or outright failure of the coating.

Figure 7.2-19. Close-up of areas of trays A9 and A10 showing environmental effects on a variety of materials. (Color figure C-30)
